耗材維修服務-ESC 維修服務

Repair Flow of AMAT ESC

Repair Level for AMAT ESC

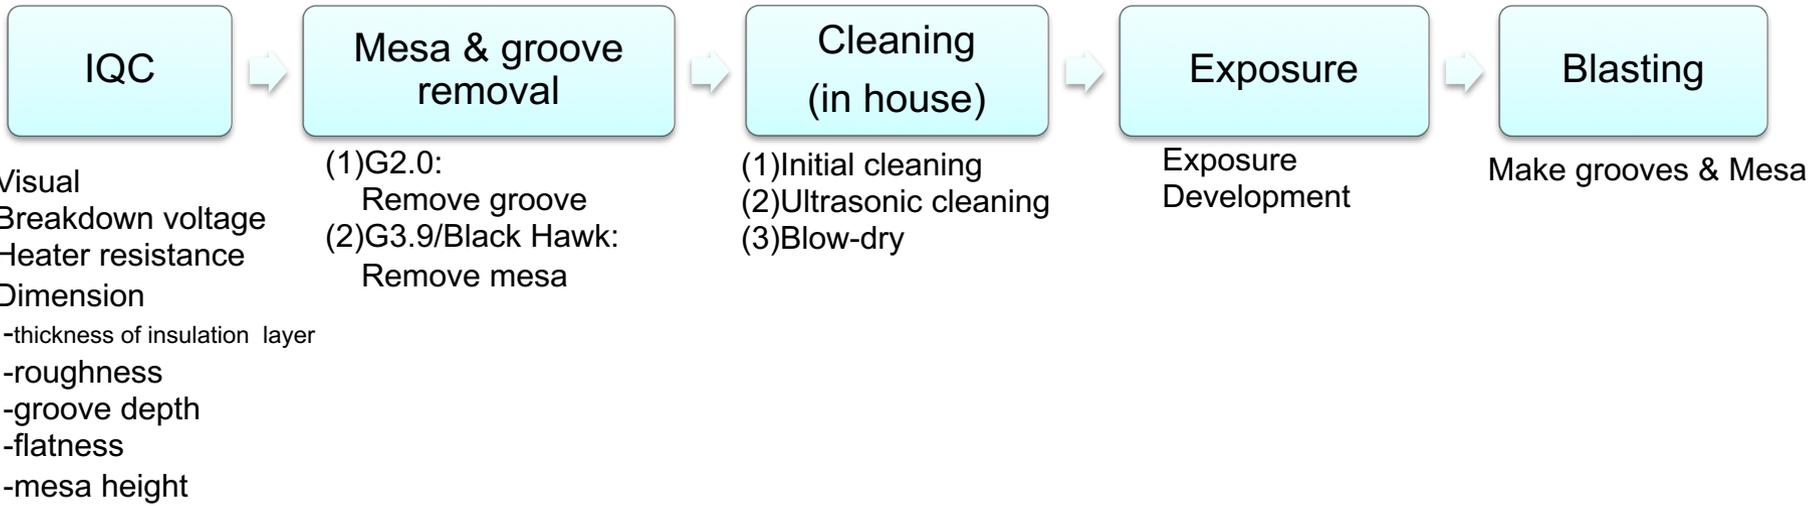
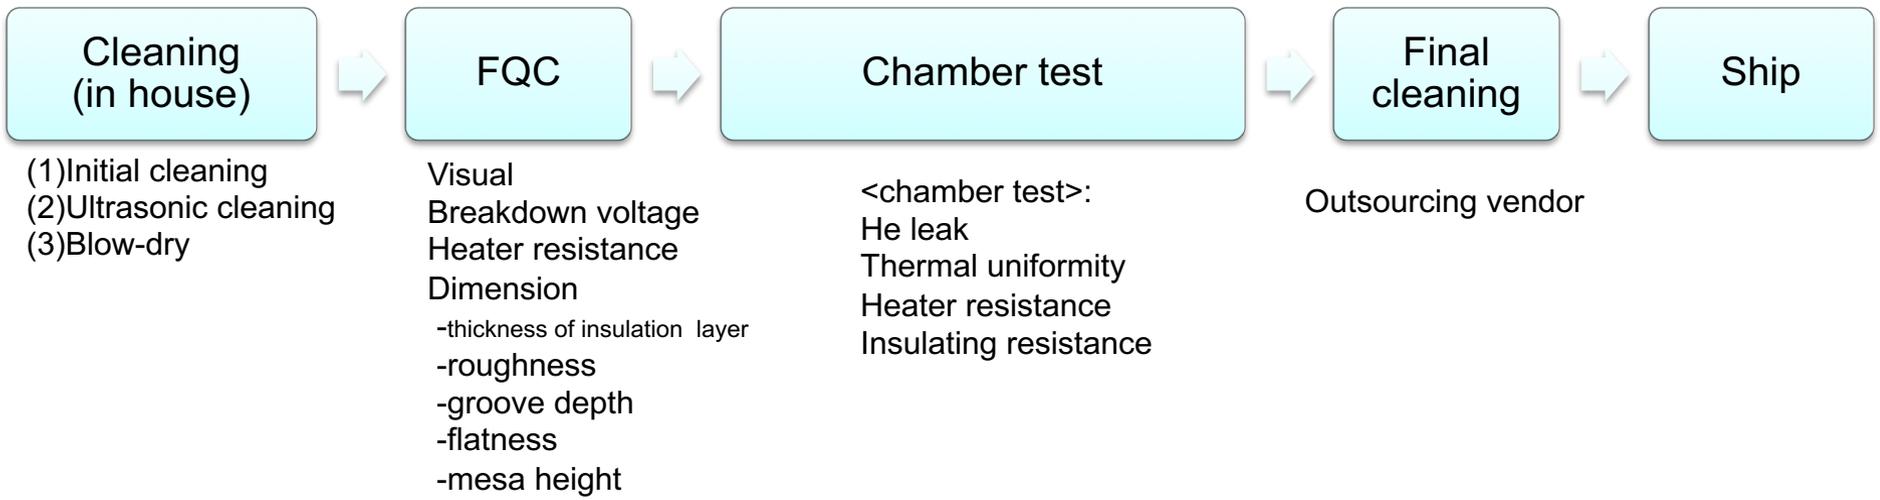
- ✓ Existing facility have a capacity as 5 pcs per month.
- ✓ Mainly customers : PSMC/TSMC/Micron
